ASHOKAN DAM

ULSTER COUNTY, NEW YORK

PHASE I INSPECTION REPORT  
NATIONAL FIRE SAFETY PROGRAM

PHASE I INSPECTION REPORT  
NATIONAL DAM SAFETY PROGRAM  
ASHOKAN RESERVOIR, INVENTORY NO. 41  
HUDSON RIVER BASIN  
ULSTER COUNTY, NEW YORK

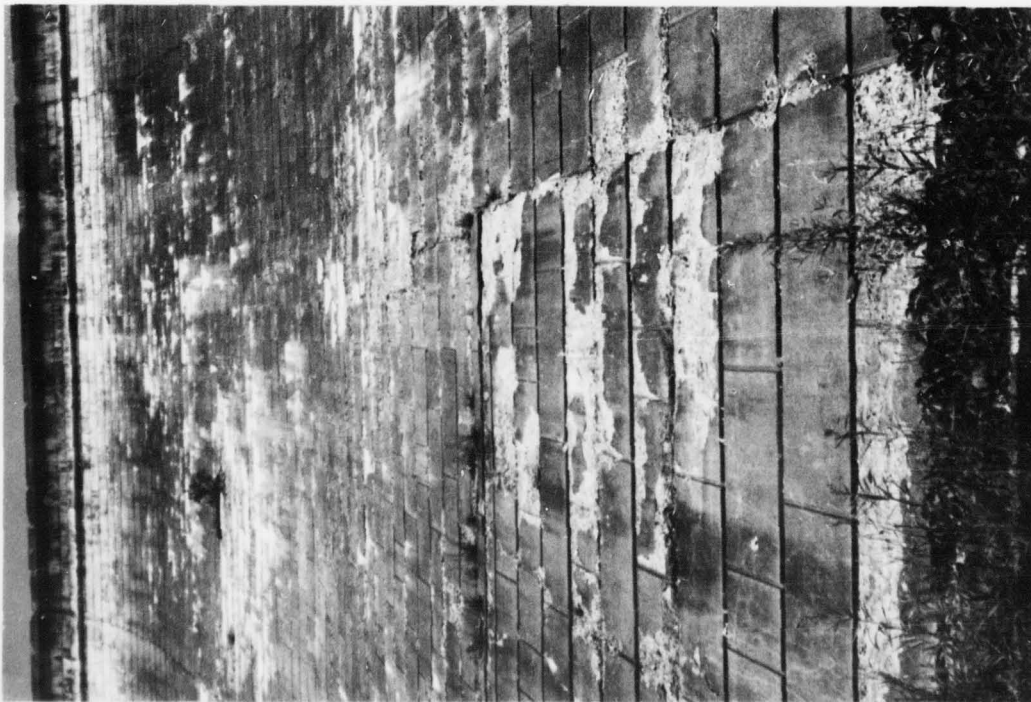
The masonry portion of the Olive Bridge Dam appears to be in generally good condition. There were no visible signs of distress or movement. There was some growth, including a sapling, on the downstream face. There were some spalling and minor cracks on the concrete surfaces of the downstream face.

Salt used in snow removal appears to be the probable cause of some deterioration and spalling of the concrete surfaces of the parapets and upper ledges on the downstream face.

The spalling of the concrete on the downstream face of the dam, including the upper ledges and parapets, is probably the result of the action of chloride ion

There were no visible leaks on the downstream face of the dam but the growth of vegetation and the presence of a sapling are possible indications of moisture at the downstream face.

DOWNSTREAM FACE OF MASONRY DAM.  
NOTE VEGETATION AND SPALLING ON FACE

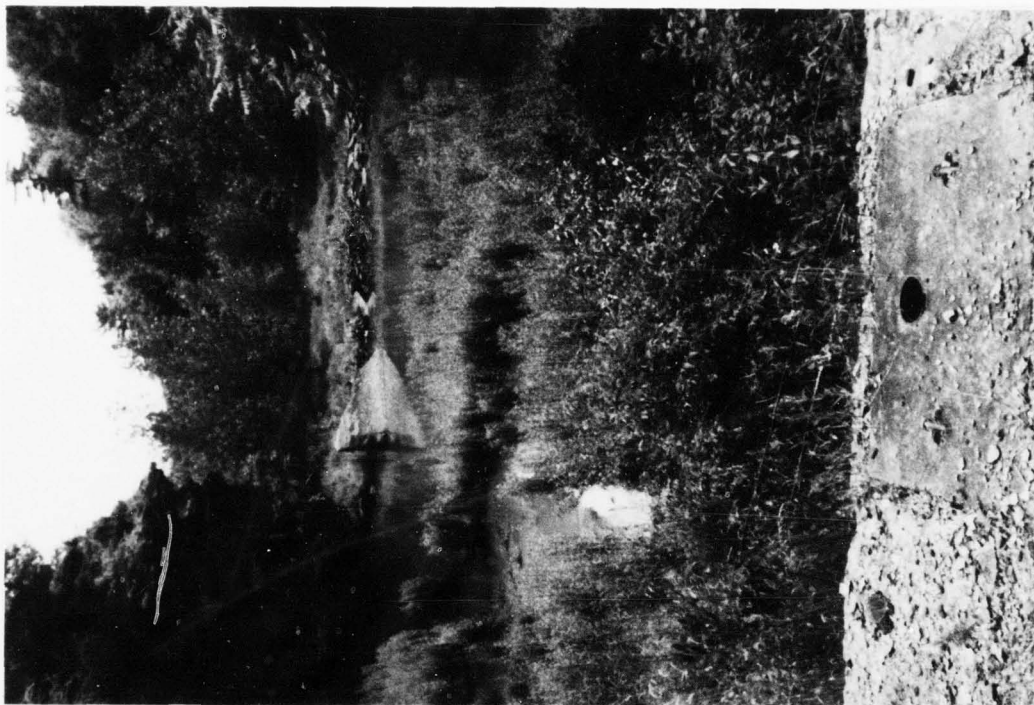
The channel downstream of the masonry dam is the Esopus Creek. Although the channel contained trees and dense bushes, its present condition would not impede discharges from the reservoir. The findings at waste weir channel are described in Paragraph 3.1 f.

DOWNSTREAM CHANNEL (ESOPUS CREEK) OF  
MASONRY DAM SHOWING VEGETATION  
AND EXPOSED ROCK

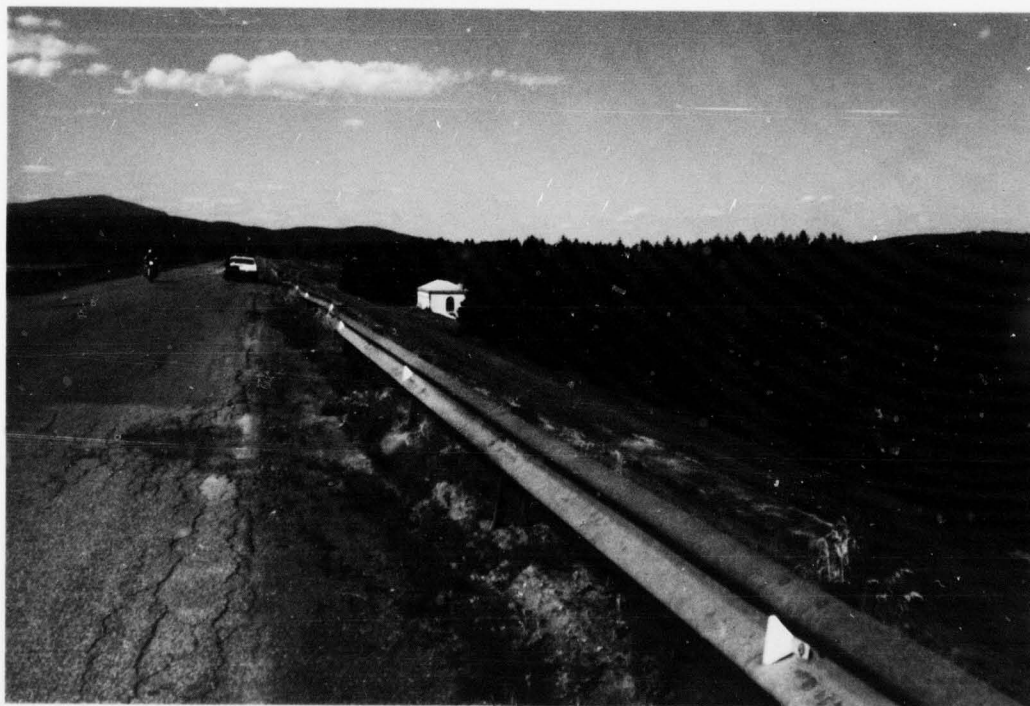
The West Dike appears to be in generally good condition; the horizontal and vertical alignments of the crest are good except for the pavement depression near the south end of the Dike as described below.

It is reported that during the winter or early spring of 1978 the downstream slope near the south end of the Dike was affected by sloughing which was caused by heavy surface runoff. It appears that the sloughing occurred downslope of an area where the roadway pavement has undergone cracking and differential settlement. The maximum settlement in the area is as much as 2 inches. From the observed signs it appears that pavement deterioration in this area may have been occurring gradually or periodically after each rainy season causing the cracks to open wider and the roadway to tilt toward the downstream slope, thereby collecting more and more surface runoff during major storms. The sloughing may have been triggered by the buildup of water pressure in the layer of crushed rock which, according to the contract drawings, underlies the topsoil and clayey earth layer on the downstream slope. Uplift pressure on the underside of the impervious soil cover would then result in sloughing. The area affected by sloughing is 100 ft wide at the top of slope and 50 ft at its downslope limit. The slope was repaired by placing fill and turf on the slope. The pavement distress has not been corrected.

VIEW OF DOWNSTREAM SLOPE OF WEST DIKE LOOKING NORTH.  
NOTE PAVEMENT FAILURE AT CREST AND REPAIR OF SLOPE

Local depressions and cracking of the pavements on the West Dike and West Hurley Dike should be repaired.

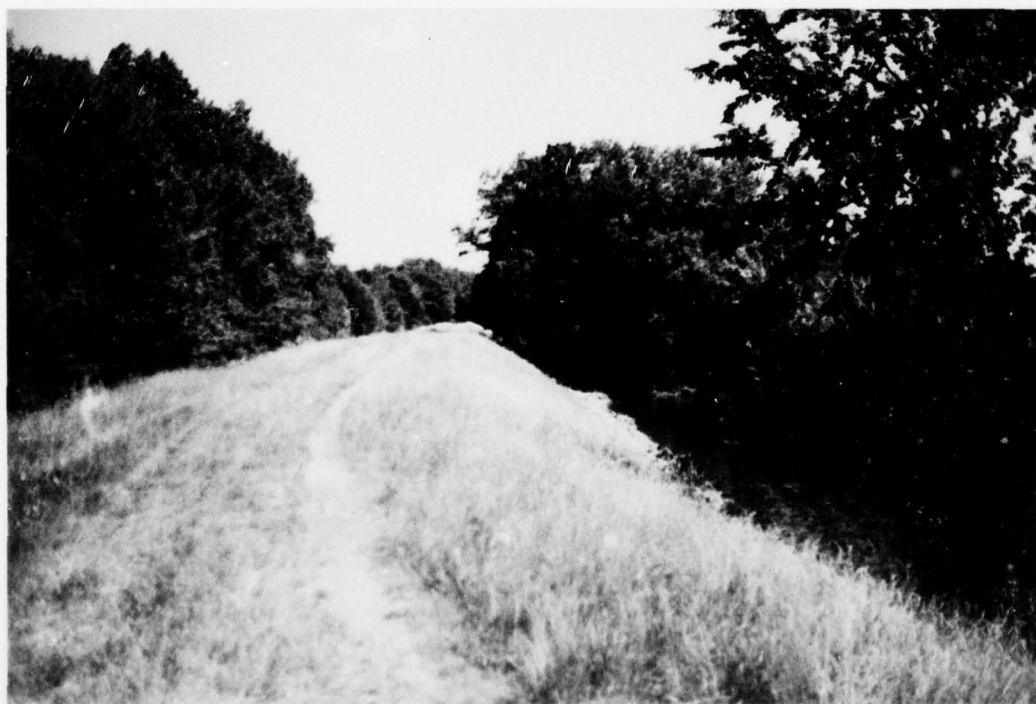
OVERVIEW OF CREST AND UPSTREAM SLOPE OF WOODSTOCK DIKE .  
(LOOKING EAST) NOTE PATHWAYS AND OVERGROWN GRASS.

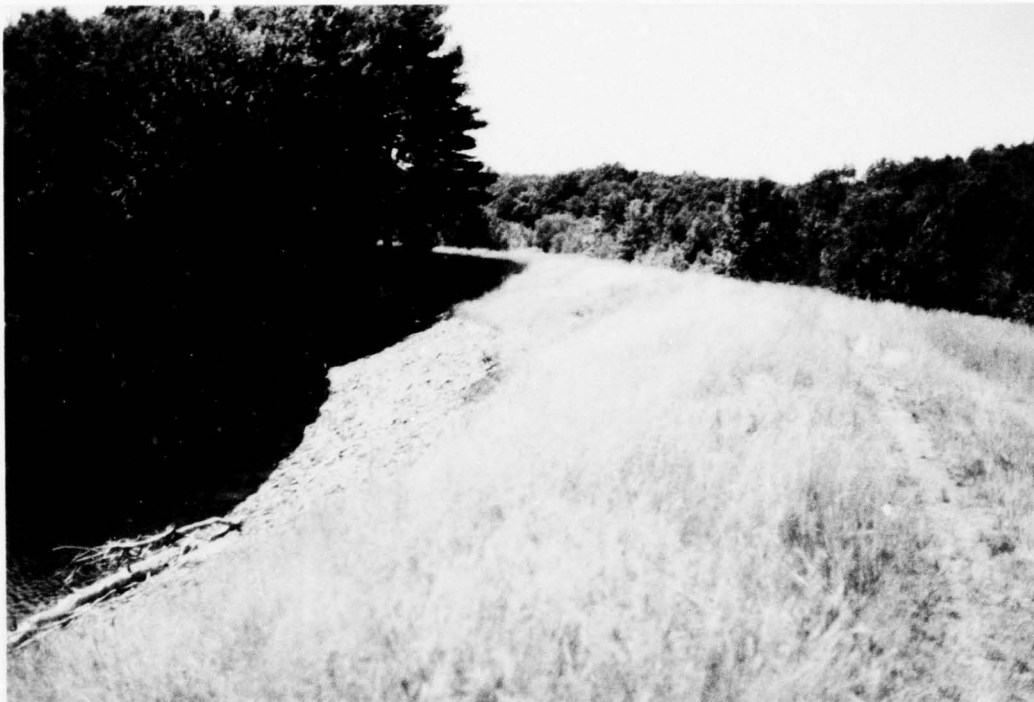
OVERVIEW OF CREST AND UPSTREAM SLOPE OF WOODSTOCK DIKE.  
(LOOKING WEST) NOTE PATHWAYS AND OVERGROWN GRASS.

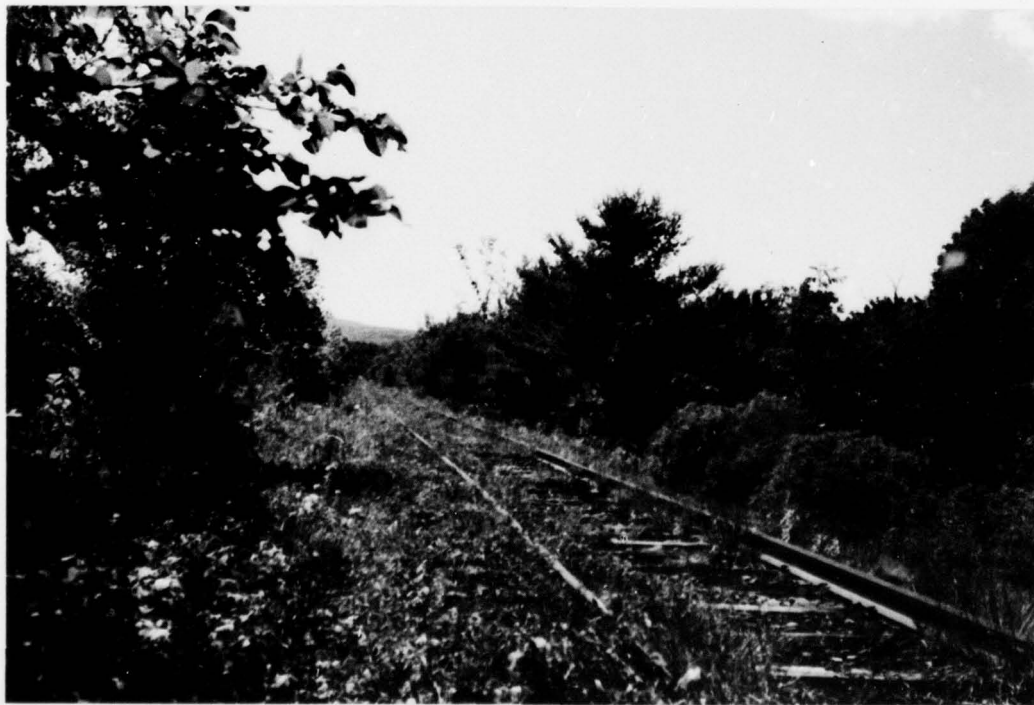
VIEW OF CREST OF GLENFORD DIKE. (LOOKING WEST)  
NOTE ABANDONED RAILROAD TRACK AND HEAVY VEGETATION

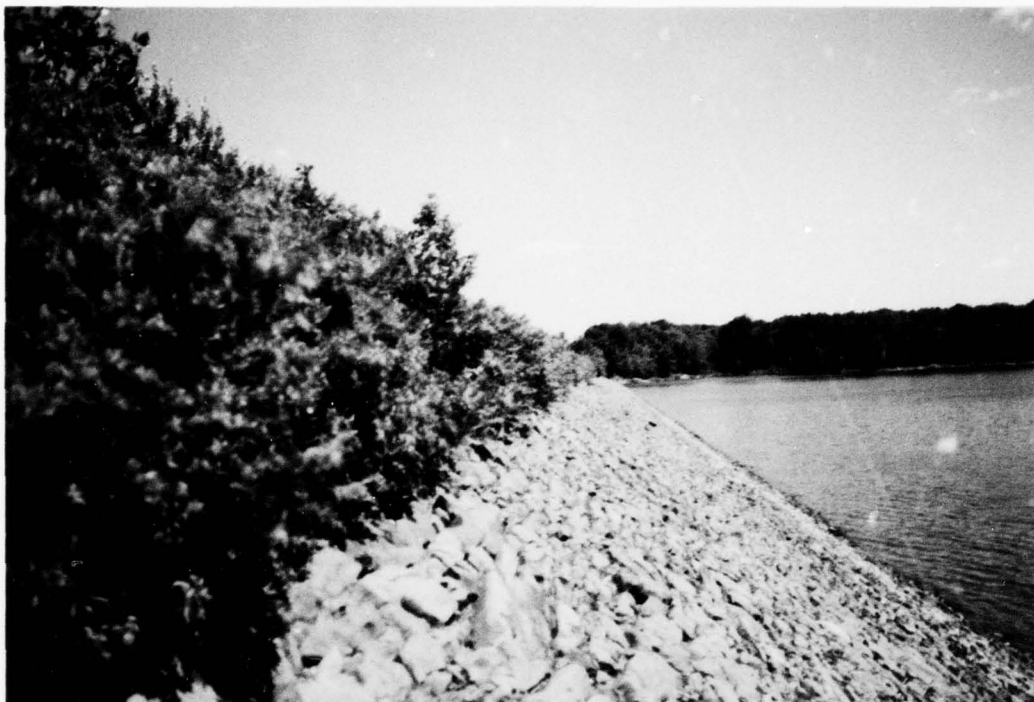
UPSTREAM SLOPE OF GLENFORD DIKE. (LOOKING EAST)  
NOTE RIPRAP AND HEAVY VEGETATION.

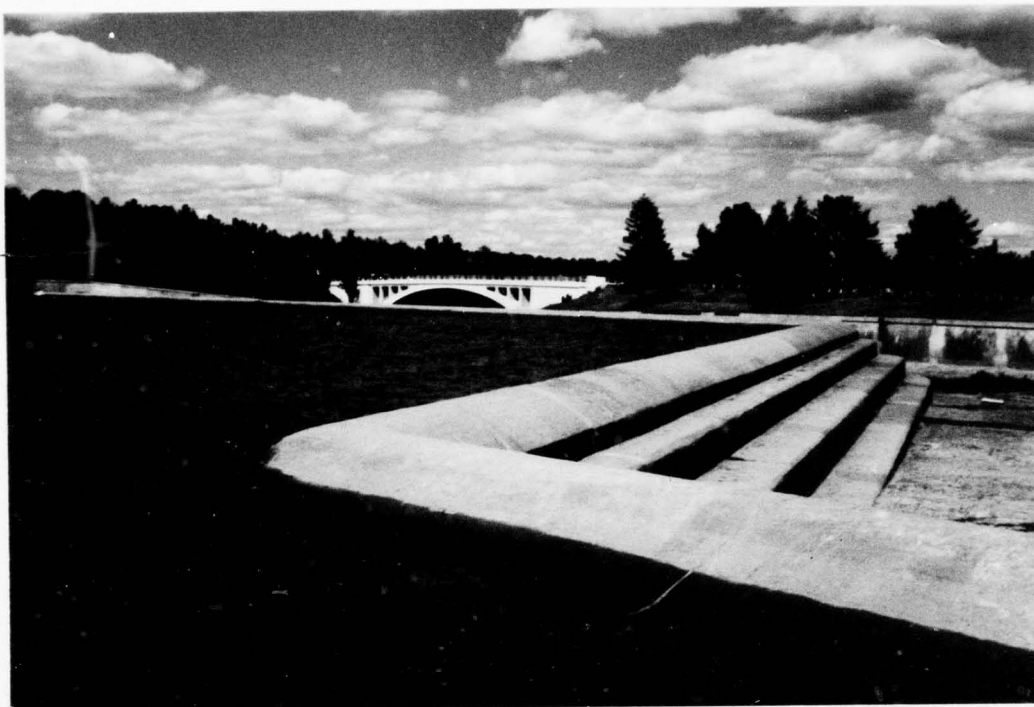
OVERVIEW OF SPILLWAY CREST AND RESERVOIR. (LOOKING NORTH)  
NOTE MINOR VEGETATION.
